WHY MY BUILDING WINDOWS ARE LEAKING !

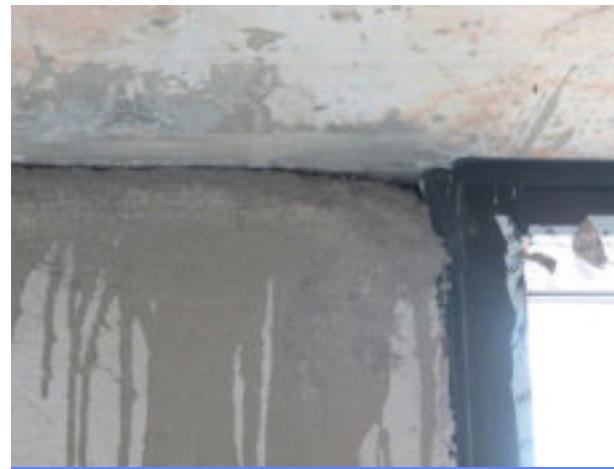
Joins not treated, leakages at wall and roof

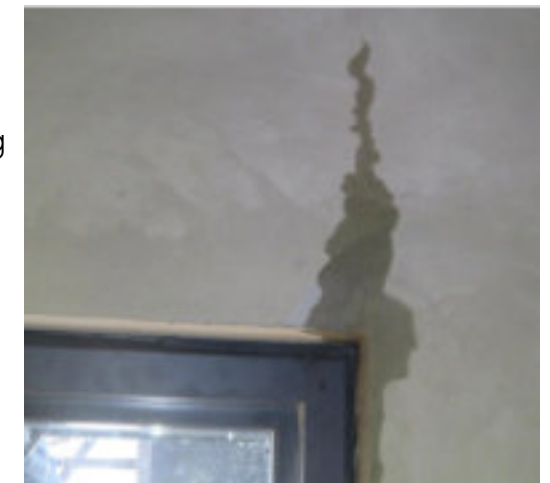
Leakage due to Cracked Concrete

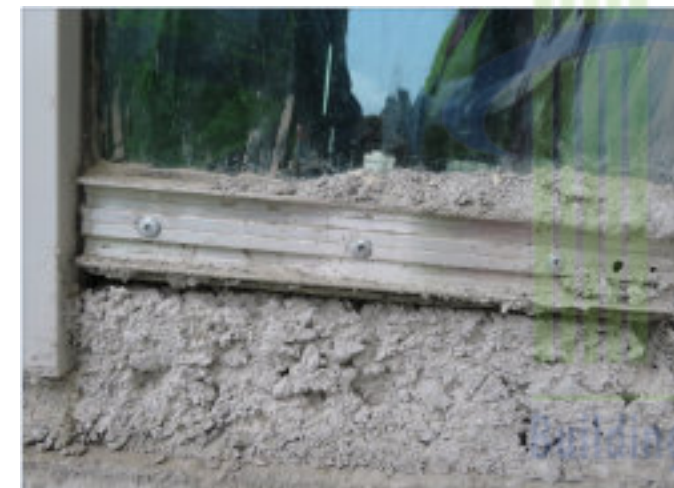
Loosely filled mortar, can't achieve good waterproofing

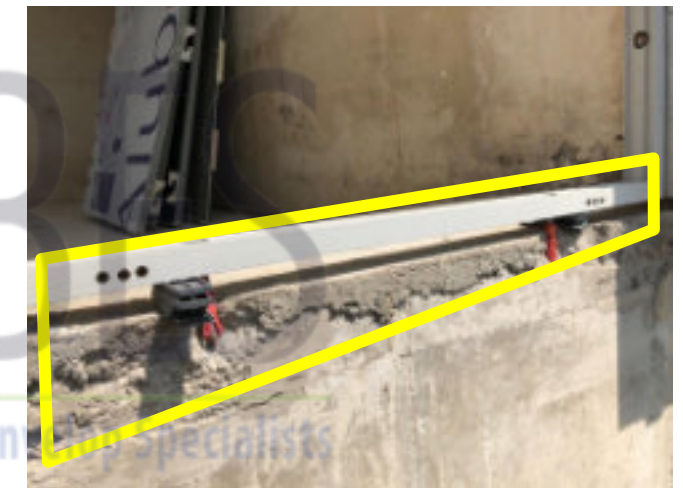
Poor Concrete Opening, Window perimeter sealing very difficult and risk of water seepages

Windows opening tolerance, having a wide gap or no gaps makes waterproofing very weak. Window frames are pre-fabricated, designed for site adjustment with reasonable tolerances. But building openings (Civil works) must comply with acceptable tolerances. it is not practical to follow too much varying site dimensions for each window.

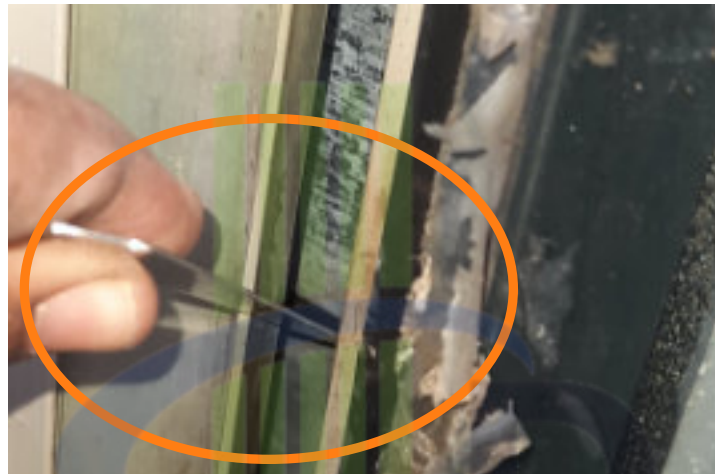
Flashing Discontinued, entry of water into joints

If the concrete or wall openings are not consistent due to poor constructions, then windows perimeter sealing must address appropriate details as per site conditions. In these cases, dual sealing (inside and outside) using flashing and waterproof membrane shall be considered. It can be further avoided by providing necessary drain slots and slopes for water to flow or drain out from the façade.

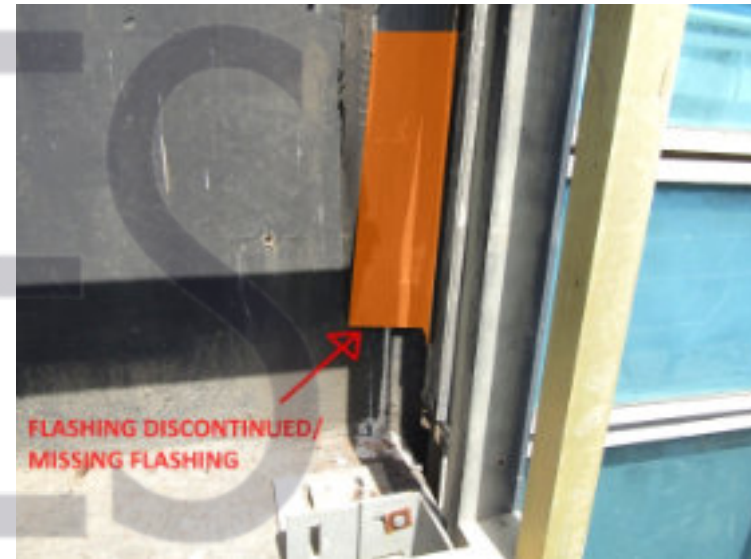
Flashing Discontinued at Interface, risk of leakages

Windows perimeter sealing with the building concrete openings is critical to achieving weatherproofed details. Often waterproofing is compromised at the corners or there are no overlaps for longer joints. Good design details will address these issues. However, site implementation skills impact the performances.

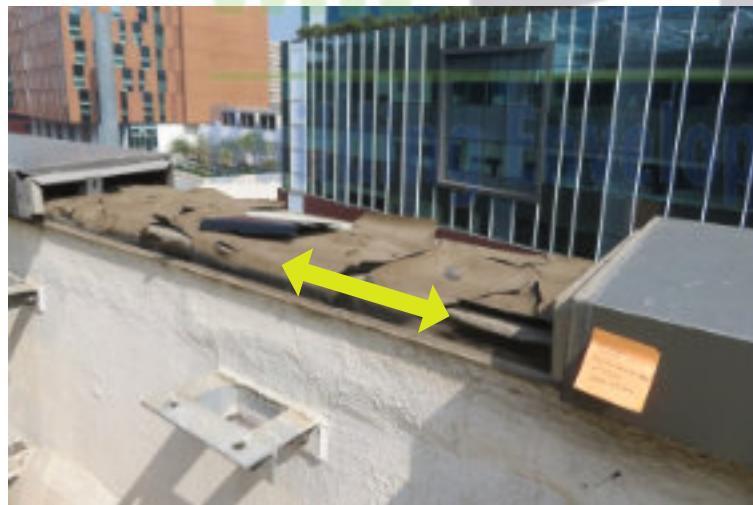
Waterproofing layer weathered out, lead to seepages

Materials used should be durable enough to withstand harsh external weather ie, rain, wind & heat. Poor quality materials such as gaskets, sealants, weatherproofing are generally the first barriers that get damaged due to environmental conditions such as daily sun exposure and sudden winds. Poor quality materials can often degrade quickly in just few years. This will increase risk of water leakage and impact facade performance.

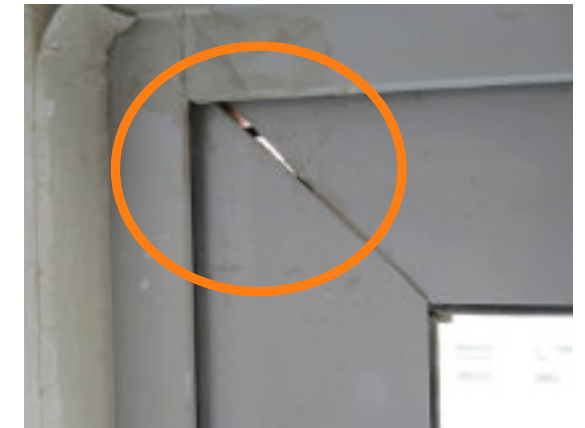
Incorrect Corner Joint- Poor Fabrication

Various workmanship issues such as misaligned fixing, poor fabrications may lead to site defects. If frameworks are not fabricated as per allowable tolerances and connections don't follow good practices, it will leave gaps in frame joints and lead to water seepages. Often these defects are rectified by applying weather sealant over the surface, but these quick fixes will not last long.

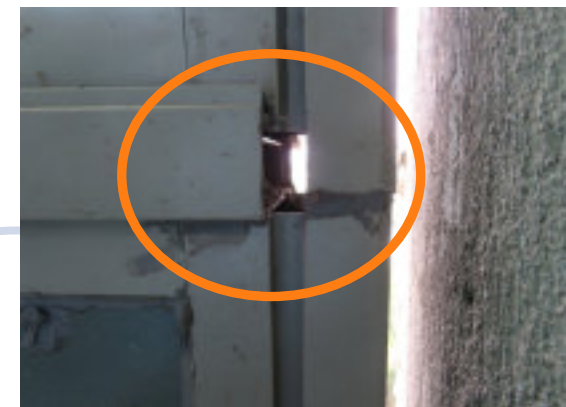
Gutter not sealed / joined at ends, holes in facade

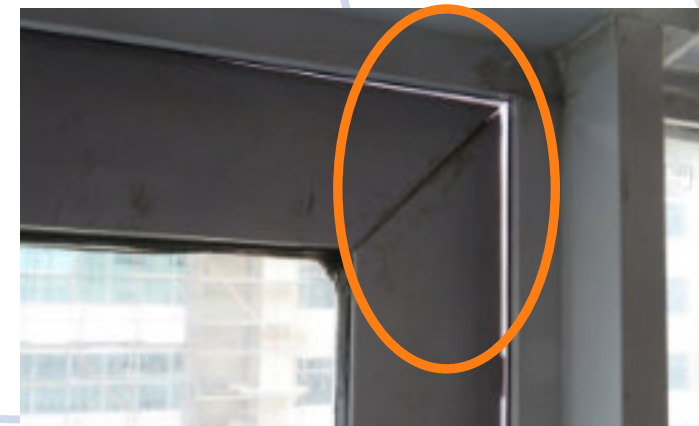
Openable window with gaps - Not sealed

Windows and openings need to be correctly sealed in closed conditions. Use of the right hardware and correct design approaches help to seal the openable sashes to withstand extreme weather conditions. The pre-fabrication approach is highly recommended to avoid more site works. Hardware fixing requires a good level of skill set so that hardware can perform its functions properly.

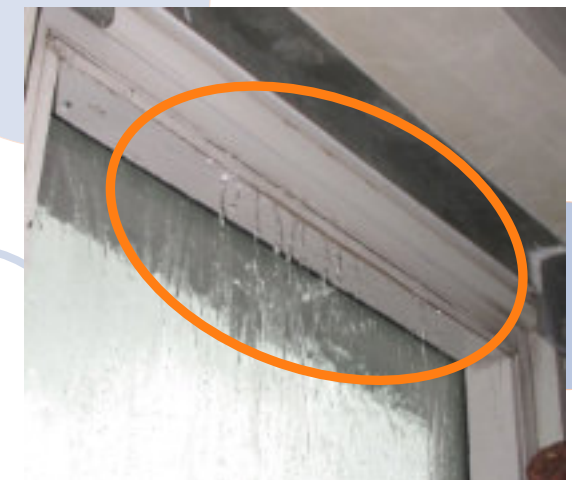
Leakage due to poor hardware & Gasket

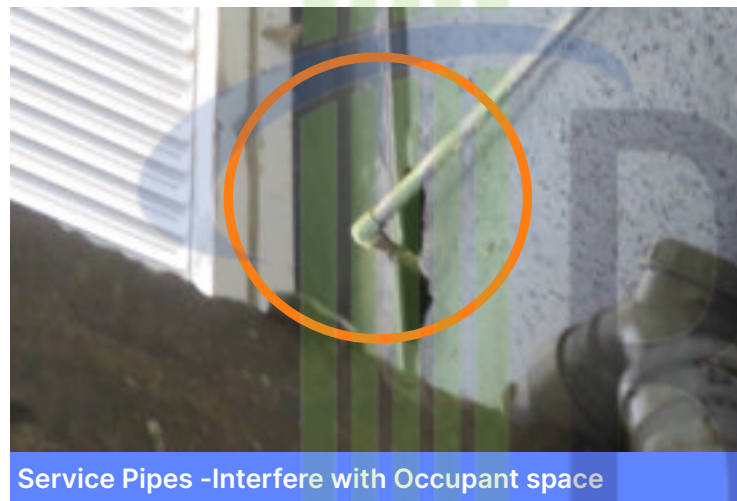
Service Pipes -Interfere with Occupant space

Residential facades are more function driven whereas commercial facades are more aesthetic driven. However, design requirements and challenges are very different among these type of building facades. Careful thought should be given at design stages to well integrate services and penetrations so that it will not interfere with windows or facades. Afterthought works may lead to compromise on building envelopes.

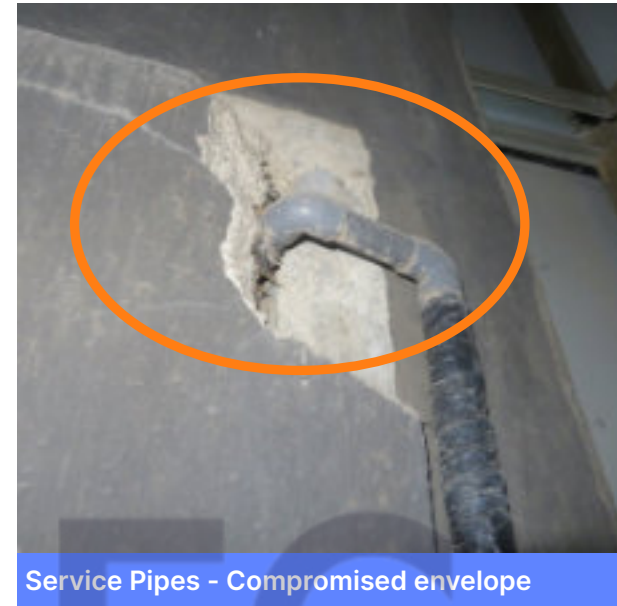
Service Pipes - Compromised envelope

Adhoc approach and post completion changes by other trades, will compromise durability and performance of building envelopes. These defects can be avoided with well resolved pre-construction designs

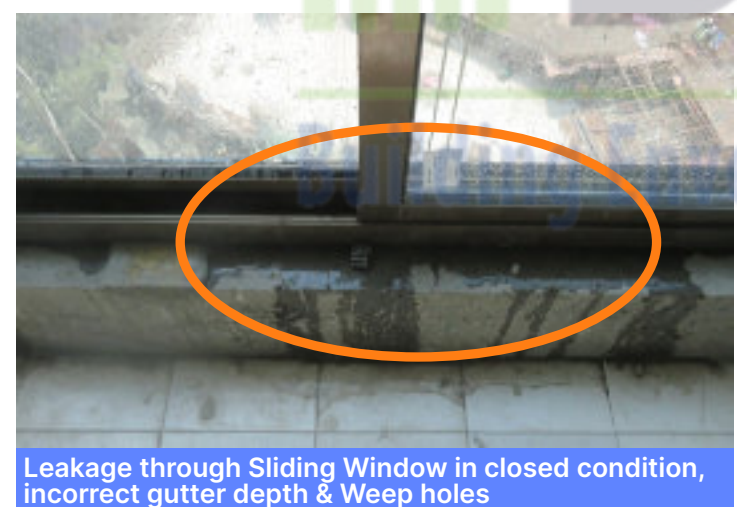
Leakage through Sliding Window in closed condition, incorrect gutter depth & Weep holes

Uneven concrete openings are not rectified prior to window fixings and poorly designed track profiles can lead to water ponding and inability to drain .

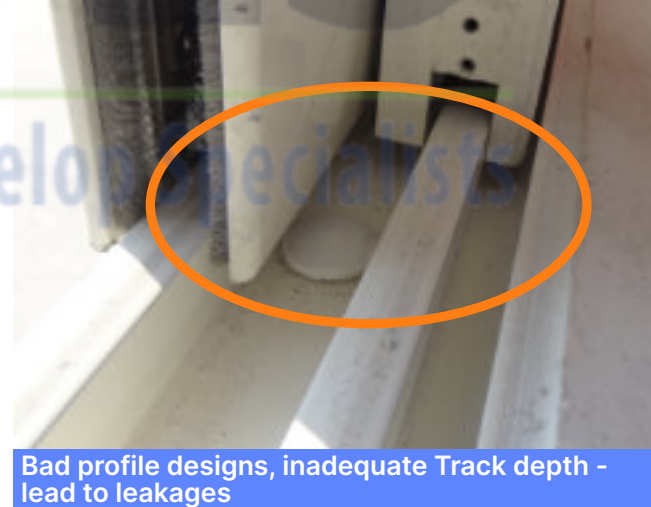
Bad profile designs, inadequate Track depth - lead to leakages

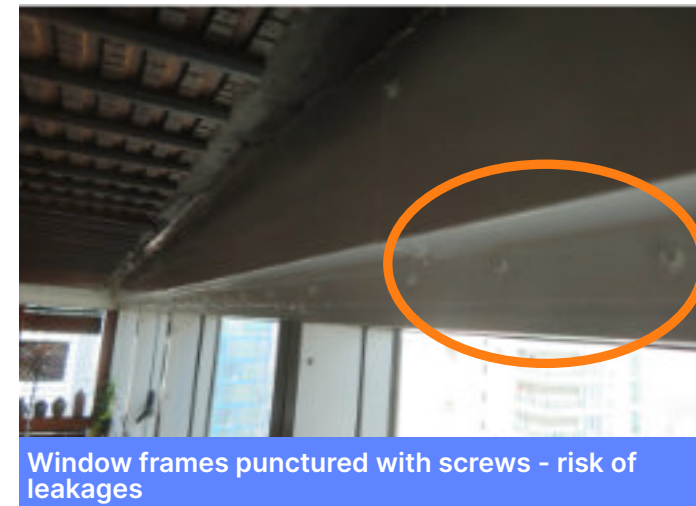
Window frames punctured with screws - risk of leakages

Often damages due to interior works can lead to severe leakages and pose challenges to rectify. Certain damages are beyond repair. As a general rule, no interior works should come in contact or overlap with windows. Avoid screw fixing, puncturing frame works, decorative cladding, etc.

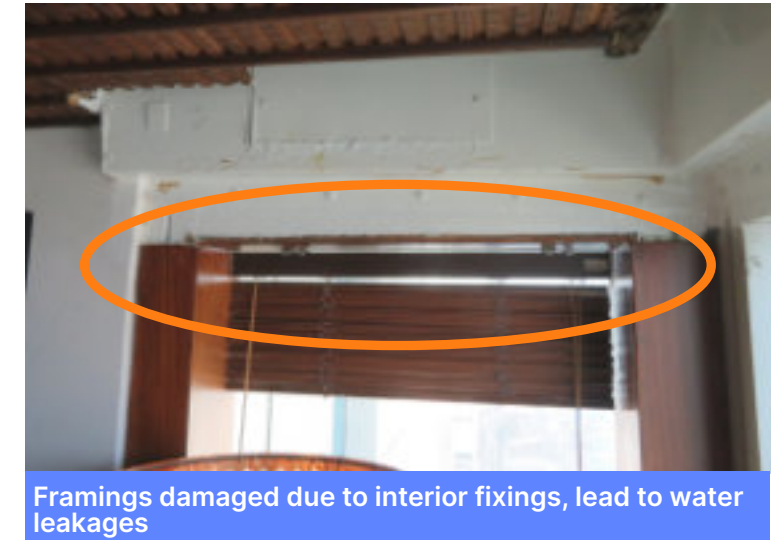
Framings damaged due to interior fixings, lead to water leakages
